Trouble shooting

| 02-3433-7715 | bspark@ssyenc.co.kr

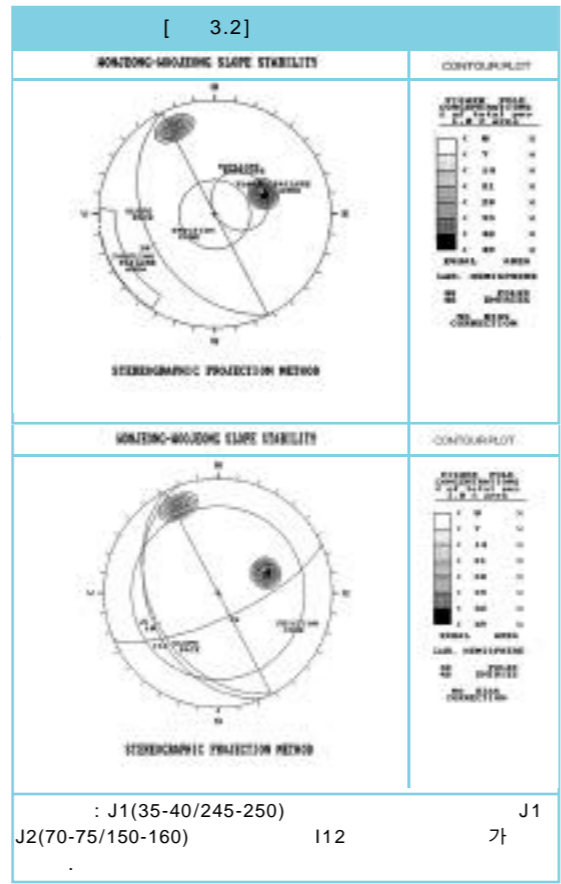
[3.1]					
J1	J1	J2	(I12)	-

가
 [3.2] < 3.1 >
 SMR SMR 6.5
 V , Very bad ,
 (Completely
 unstable) ,
 (Big planar failure) (Soil-like
 failure) . SMR

Reexcavation
 . < 3.2 ~
 3.3 >
 가
 (: $j=25.0$,
 C = 0.0t/m) , J1 J2 (238/34)
 0.74, 0.51
 (1.5, 1.2)
 . [3.3]

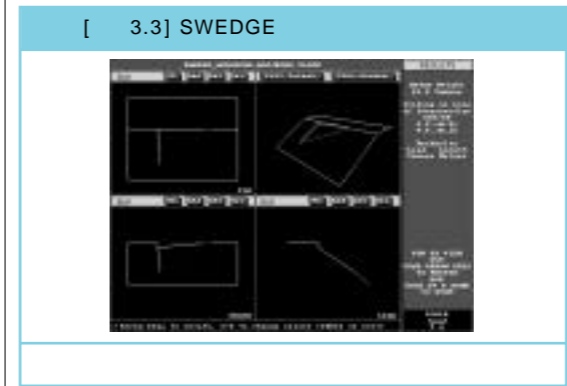
< 3.4 > SWEDGE			
(J1+J2)	1.5	0.74	
	1.2	0.51

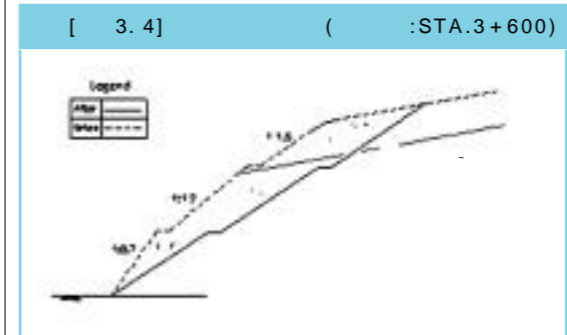
가
 (, ,)
 ()
 가
 Plunge
 (Plunge)34°
 (1 : 0.7 1 : 1.5, 1 :
 1.2~1.5 1 : 1.5)
 . [3.4]

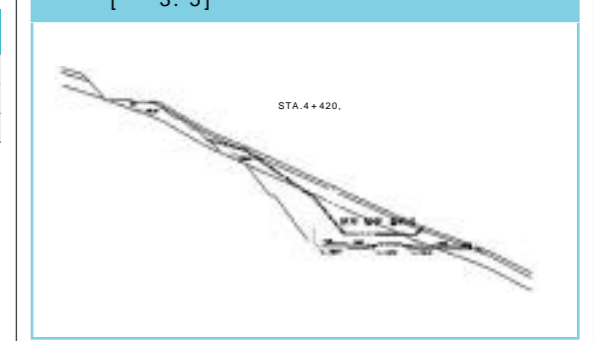
3.2
 가)
 STA. 4 + 360 ~ 4 + 500
 [3.5]
 ()가
 , 가 ,
 .

가
 . :
 ()
 . :
 (N17W) 30° N13E
 가
 (H.W) ~ (C.W)
 (M.W)

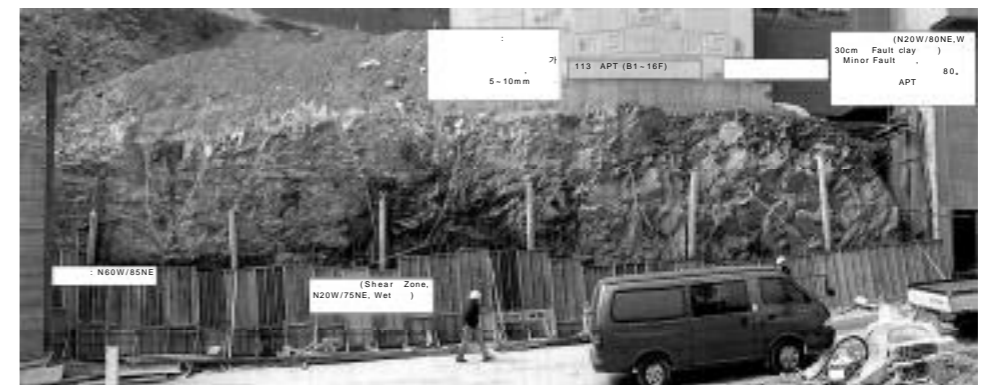
[3.7]

)
:
(Biotite Gneiss)
(Rock Test Hammer, Sanyo) 가 1,500kg/cm² (Very Strong)
(S.W) ~ (M.W ~ S.W)
: 4 Sets (J1: N20W/80NE, J2: N50E/55NW, J3: N15W/80SW, J4: N40E/15SE)
6~20cm, 0.2~0.6m
Shattered ~ Blocky
<6cm Sheared Persistent , (S.R), (Tight) (Dry)

(Shear Zone) (Wet) .
: 가 가
(N20W/80NE, W 30cm Fault clay) Minor Fault가
4Q
8Q APT
(Biotite Gneiss)
(Rock Test Hammer, Sanyo) 가
APT
(J2)
5~10mm MAT
가 cm
.[3.7]
APT
가

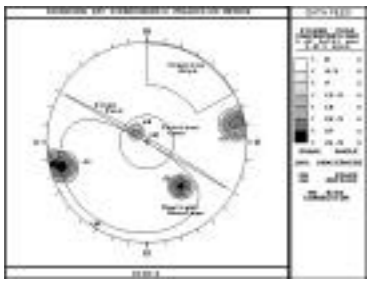
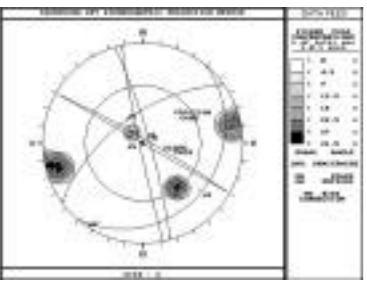
)
 Barton
 (1973) $j =$
 $35.0, C = 1.0 \text{ t/m}^2$
 가
 [3.8] < 3.6
 > 가 [3.9]
]
 $0.68(1.5)$, $0.65(1.2)$

J1 J2 (I12) J1 J3 (I13)
가

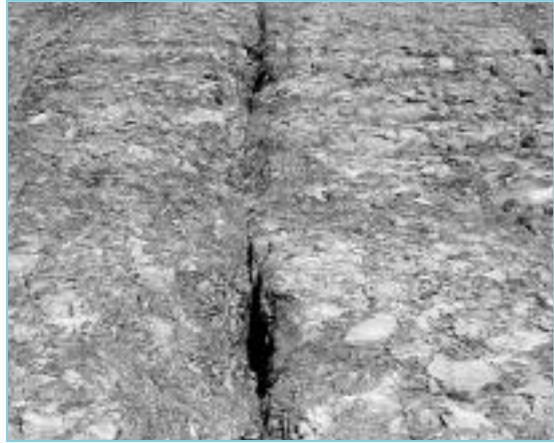
,
 Slaking
 S.W ~ Fresh
 H.W ~ M.W
 : (0 ~ 10)
 3 Sets
 Massive
 Massive ~ Blocky
 6 ~ 20cm
 Shattered , (<6cm) Sheared
 :
 Warping
 (Fault Zone)
 (Normal Fault)
 (Step Fault)
 0.5 ~ 2.0m
 0.1m ~ 0.3m 1.0m
 ~ 90° [3.12]
 가
 70°

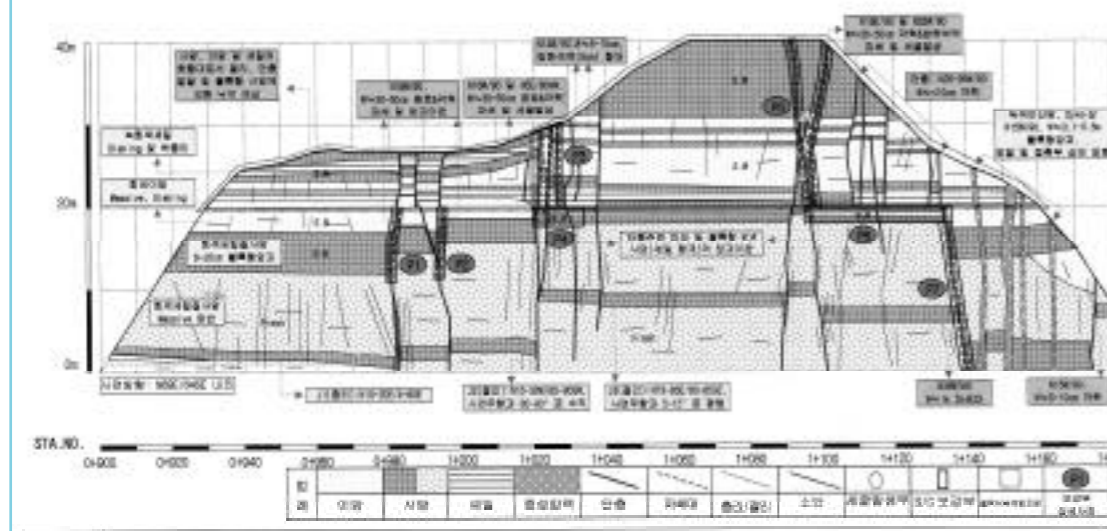
[3.13] B Face Mapping (STA.NO.0+900 ~ 1+180)

(Massive)	
가	(, /)	가 Slaking
	Slaking, (Fissility)	
가	/ S/C	가
